ANNUAL REPORT FOR 2015

Banks School Road Buffer Mitigation Site Lenoir County TIP No. R-2719A

COE Action ID: 200511238 DWR Project #: 20050787

Prepared By:
Roadside Environmental Unit & Natural Environment Section
North Carolina Department of Transportation
June 2015

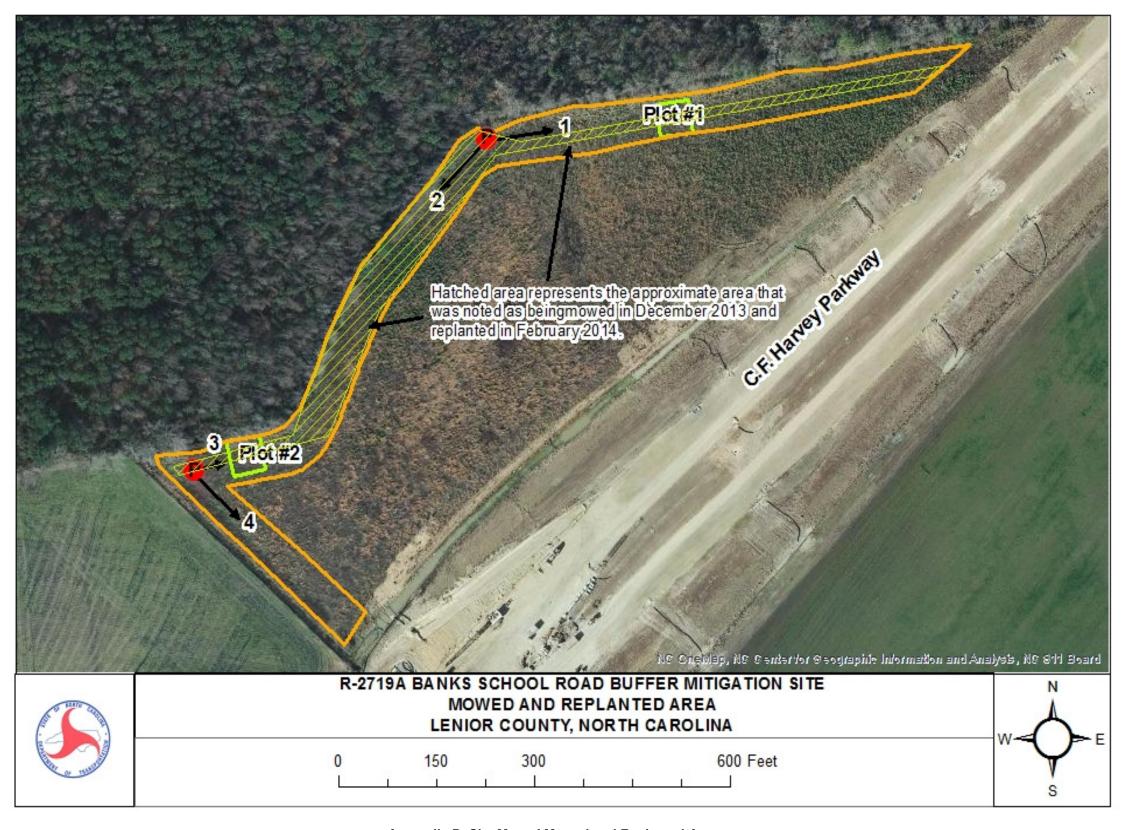
Appendix D. Site Map of Mowed and Replanted Area

In December 2013, NCDOT personnel noted that a portion of the buffer had been mowed. In February 2014, the mowed portion of the buffer was replanted, locks were installed on all gates into the site, and mitigation signs were installed at the site to prevent further encroachments. See Appendix D for site map of mowed and replanted buffer. In September 2015, NCDOT sprayed an herbicide application on the privet noted onsite as requested by NCDWR.
